**RESEARCH ON THE BASIC NATURE OF STRESS CORROSION  
FOR VARIOUS STRUCTURAL ALLOYS AT ROOM AND  
ELEVATED TEMPERATURE**

TECHNICAL REPORT No. ASD-TR-61-713

MAY 1962

(Prepared under Contract No. AF 33(616)-7612  
by Armour Research Foundation, Chicago, Ill.  
Frank A. Crossley, author)

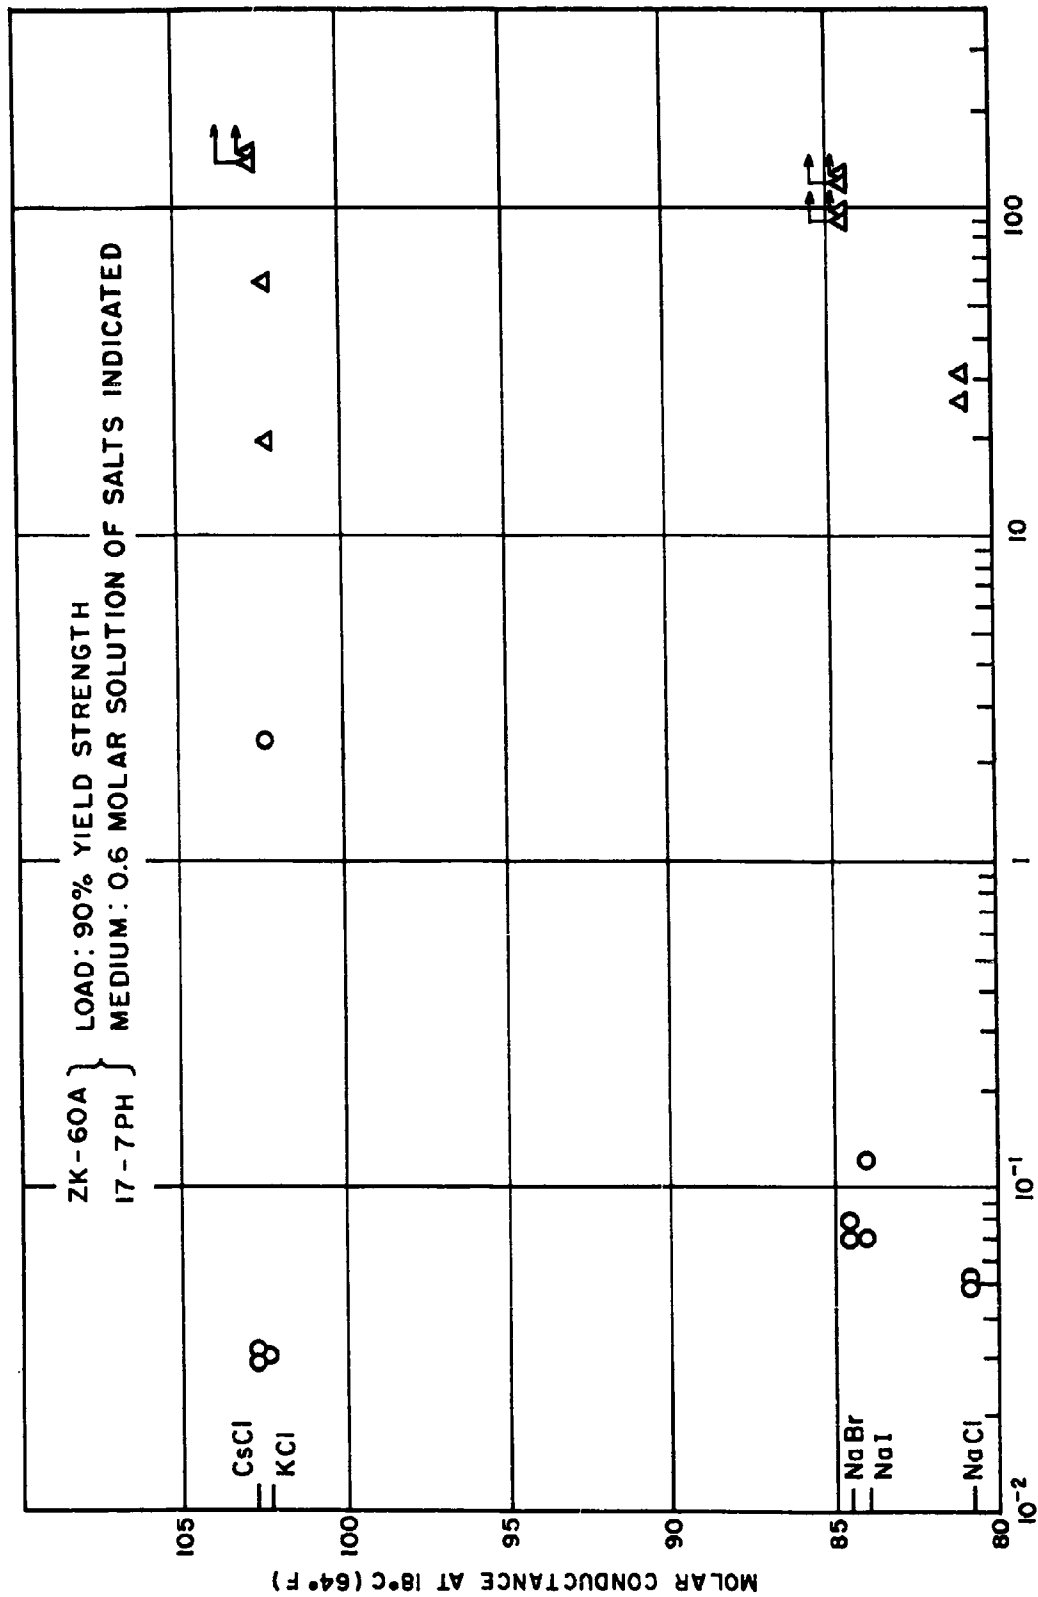
Figure 28 - Molar Conductance of Salt Solution versus Time to Failure for Stressed Specimens Of ZK-60A and 17-7PH Alloys.

The results of these tests are summarized in Table 26. All of the B-120VCA specimens survived the exposures and in subsequent tensile test evaluation exhibited no deterioration of mechanical properties. For the other two materials molar conductance versus time to failure is plotted in Fig. 28. The molar conductances at 18°C (64°F) were taken from the International Critical Tables for 0.5 molar solutions--data were not complete for a temperature of 25°C (77°F) (6). Considering the sodium salts of the halide series it appears that time to failure is longer for increasing molar conductance. Also considering the behavior of 17-7 PH in the series of chloride salts it again appears from these very limited data that time to failure tends to increase with increasing molar conductance. It may be noted that with a single exception the ZK-60A specimens failed either in a pin hole or at the base of the cup. Similarly three of the four 17-7 PH failures occurred in a pin hole or at the base of the cup. Under the conditions of these tests there is a decided preference for crevice, or concentration cell, corrosion.

Consideration of the ionic conductance and the effect of ionic conductance on the changes in composition in the anode and cathode areas of an electrolytic system suggests that the apparent correlation exhibited by Fig. 28 is merely superficial and the relationship between species of anion, cation, test material, and stress corrosion behavior is, needless to say, very complex. It is especially interesting that the CsCl solution did not produce stress-corrosion failure in 17-7 PH although the other two chloride salts did. Of course, an uncontrolled variable of considerable importance in these tests was oxygen content. This is especially important because of high proportion of failures at crevice sites.
